**FEASIBILITY STUDY OF A MITIGATION
BANK FOR BOTH PRIMARY HEADWATER STREAMS
AND WETLANDS AT THE PORTSMOUTH
GASEOUS DIFFUSION PLANT IN
PIKE COUNTY, OHIO**

**Jennifer Bowman, Kelly Johnson, Gary Conley,
Rob Wiley, Natalie Kruse, Steve Porter**

June 2014

Sponsored by Ohio University's PORTSfuture Project

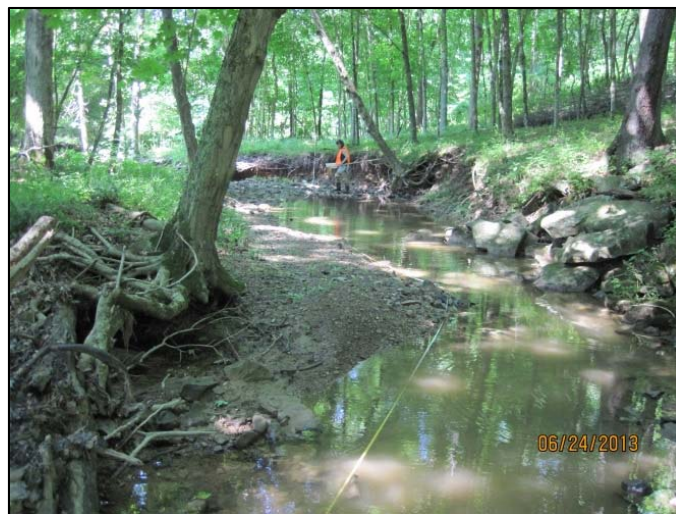
Photo 1. Trib 1A. 6.24.2013

Site Description: Trib 1A is located on the north side of DOE property, and flows into Little Beaver Creek. The stream reach meanders through a mature bottomland hardwood forest with a wide riparian corridor on both sides (Photo 1). The reach is relatively low gradient (Figure 5.1), has high sinuosity, and 60% boulder and cobble substrate. It drains approximately 0.93 square miles (593 acres), of which 47 % is forested.

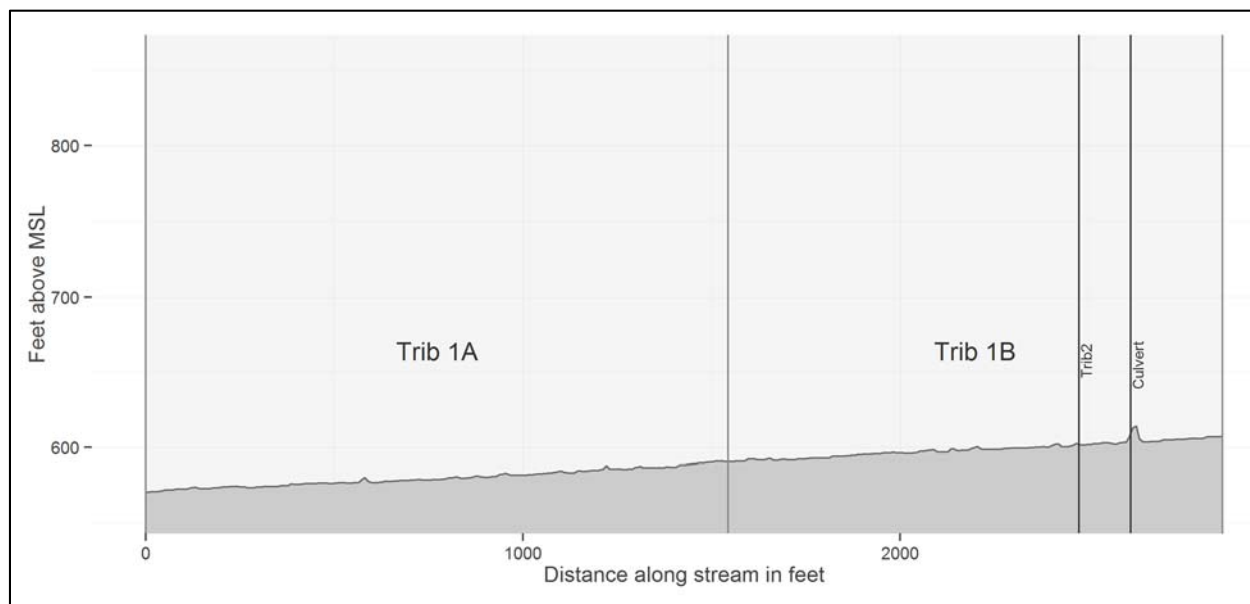
Figure 5.1 Longitudinal stream reach profile, sites Trib 1A and Trib 1B

Macroinvertebrates: HMFEI score (37). This reach supported a high quality macroinvertebrate community, with an HMFEI score well above the cut-off (>19) indicative of a Class III PHWH stream. A Level 3 assessment was performed, and although > 6 EPT taxa and 5 sensitive taxa were found only 1 cold water (CW) taxon (*Amphinemura* stonefly) was identified (Table 5.1). Thus, this stream is reported as Class IIIA.

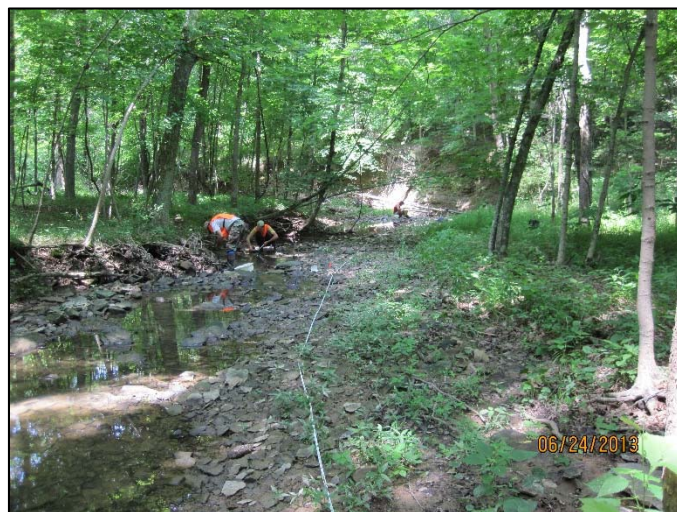
Photo 2. Trib 1B. 6.24.2013

Site description: Trib 1B located just upstream from Trib 1A is on the north side of DOE property, flowing into Little Beaver Creek. The stream reach flows through a mature bottomland hardwood forest with a wide riparian corridor on both sides (Photo 2). The upstream part of this reach is separated from reach Trib 1C by a large culvert that passes under the railroad. The reach is relatively low gradient (Figure 5.2), and has 55 % boulder and cobble substrate.

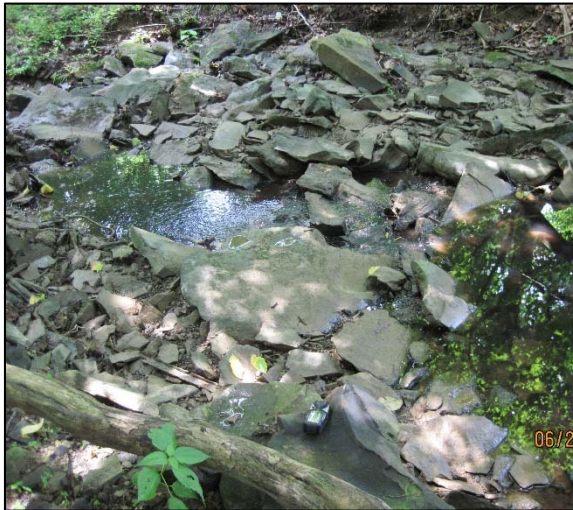
Photo 3. Trib 1C. 6.24.2013

Site description: Trib 1C is located upstream of the railroad culvert on the north side of DOE property, and flows into Little Beaver Creek. The stream reach meanders through a mature bottomland hardwood forest with a wide riparian corridor on both sides. The stream water was tinted black on site visit date, 6/24/2013 (Photo 3 & 3.1). The reach has a moderate gradient (Figure 5.2), and is 93% boulder and cobble substrate. It drains approximately 0.51 square miles (327 acres), of which 35 % is forested.

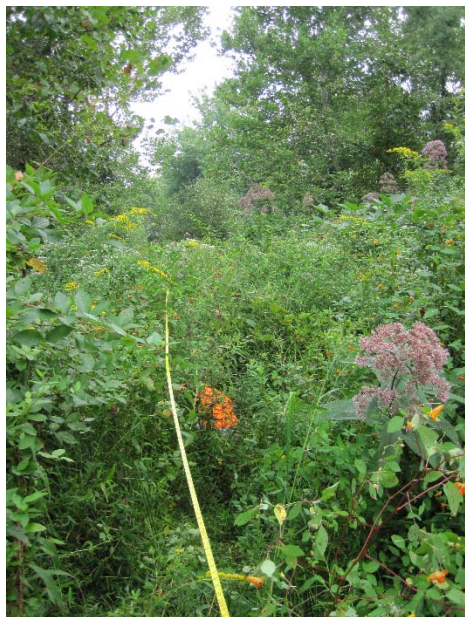
Photo 4. Trib 1D. 8.27.2013

Site Description: Trib 1D the furthest upstream reach of tributary 1 is located on the north side of DOE property, east of the north entrance road, a tributary of Little Beaver Creek. The reach had intermittent flow with isolated pools, moderate riparian width characterized by palustrine emergent and scrub/shrub habitat in the floodplain. The stream flows from an off-site lumber processing facility that is heavily populated with planted pines. The stream lacked sinuosity and was heavily vegetated (Photo 4). The reach has a flat gradient (Figure 5.4), and has roughly 60% silt substrate. It drains approximately 0.16 square miles (102 acres), of which 36 % is forested.

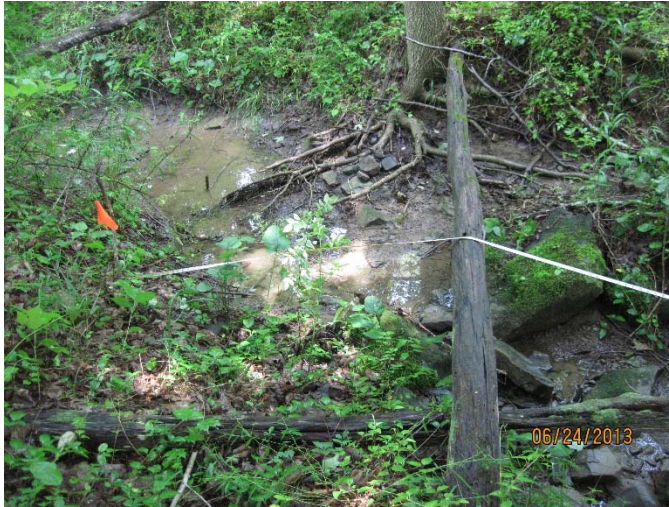
Photo 5. Trib 2. 6.24.2013

Site description: Trib 2 is a small tributary that drains into stream reach Trib 1B located on the north side of DOE property. The stream reach flows from successional forest into mature bottomland hardwood and palustrine forest cover with a wide riparian corridor on both sides (Photo 5). The flow regime was intermittent with isolated pools. The reach has a moderate gradient (Figure 5.3), with minimal sinuosity. The substrate comprised of roughly 75% boulder and boulder slabs. It drains approximately 0.07 square miles (47 acres), of which 63 % is forested.

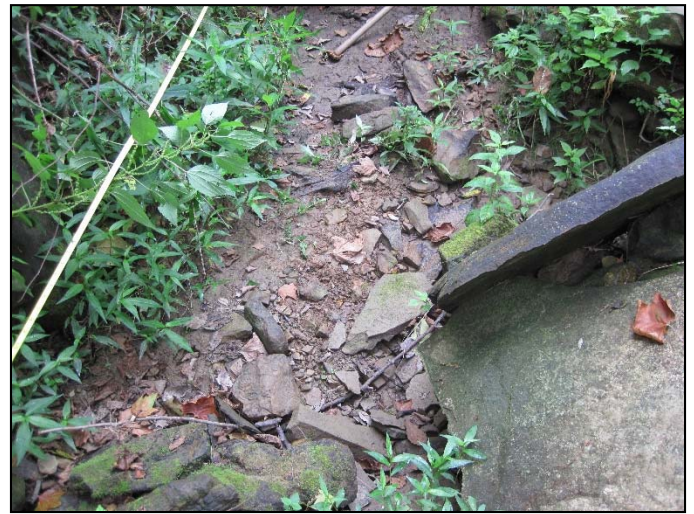
Photo 6. S1. 8.27.2013

Site description: S1 is a small ephemeral channel that drains into stream reach Trib 1C on the north side of DOE property. This stream shares ownership with off-site landowner and DOE. The reach surveyed was located partially on and partially off DOE property. The riparian corridor is narrow on left bank and moderate on the right bank; surrounded by open agricultural fields (Photo 6). The flow regime was dry with no water in channel. The reach has a flat to moderate gradient (Figure 5.4), with very little sinuosity. The substrate is comprised of roughly 71% boulder, boulder slabs, cobble, and bedrock. It drains approximately 0.17 square miles (109 acres), of which 21 % is forested.

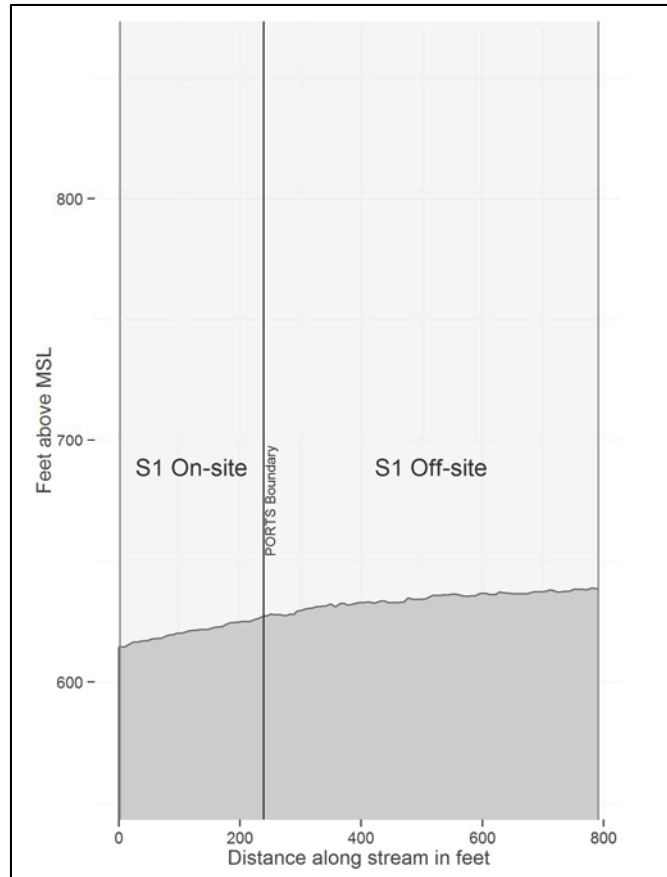
Figure 5.4 Longitudinal stream reach profile, site S1

Macroinvertebrates: HMFEI score (5) was low, only crayfish were found.

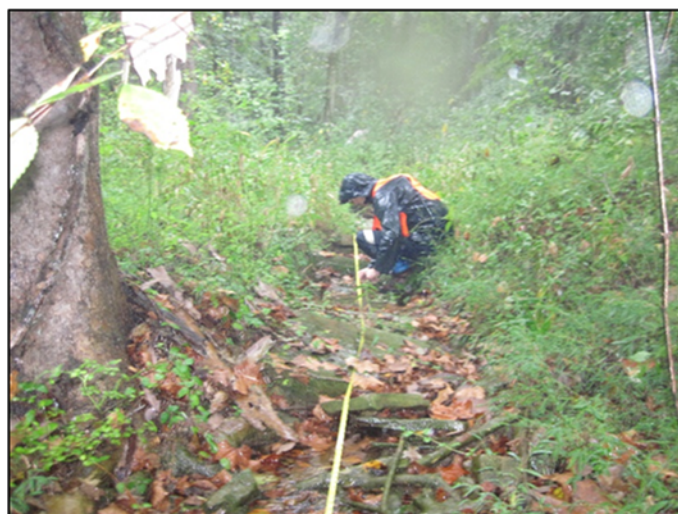
Photo 8. V1. 8.27.2013

Site description: V1 is an ephemeral stream located on the northwest side of DOE property, a small tributary to Little Beaver Creek. The stream reach meanders through a mature bottomland hardwood forest with a wide riparian corridor on both sides (Photo 8). The reach is relatively high gradient (Figure 5.5), has good sinuosity, and 70% gravel and sand substrate. It drains approximately 0.11 square miles (71 acres), of which 100 % is forested. It was raining on the date surveyed (9/19/13); small pool of rain water sampled for water quality parameters.

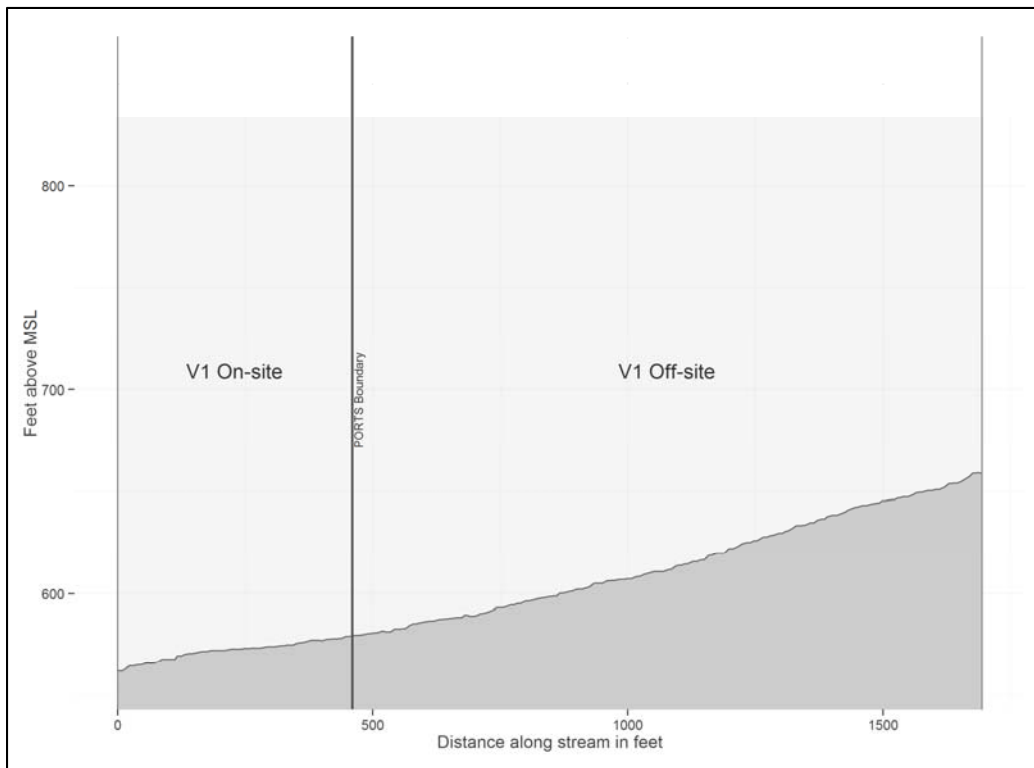
Figure 5.5 Longitudinal stream reach profile, site V1

Macroinvertebrates - The HMFEL score was very low (1) indicating poor macroinvertebrate community. Only one adult Hydrophilidae beetle was found.

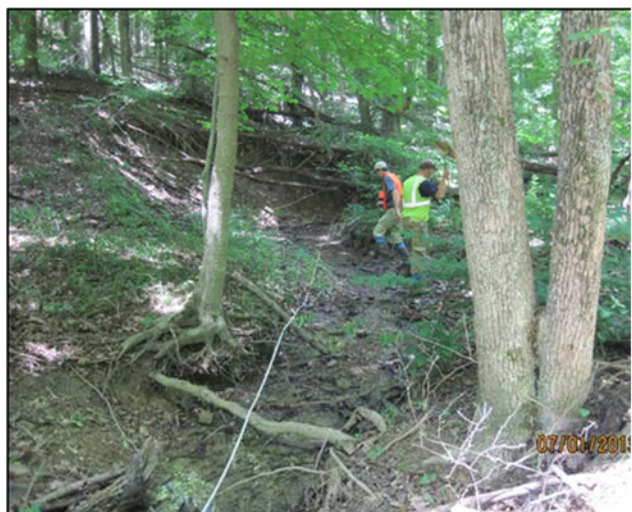
Photo 9. Trib 4A. 7.1.2013

Site description: Trib 4A is located on the northwest side of DOE property. This stream drains the Don Marquis area and is a tributary to Little Beaver Creek. Trib 4A is the headwaters of tributary 4, two section downstream of Trib 4A were also assessed. The stream reach meanders through a mature bottomland hardwood forest with a wide riparian corridor on both sides (Photo 9). This tributary's uplands are exceptionally diverse with trees aged 300+ years and riparian areas are equally rich. The reach has a moderate gradient (Figure 5.6) with its steeper section found in reach Trib 4C. Drainage from the Don Marquis to the headwaters of Trib 4A appears to have been modified resulting a new path for water to enter into Trib 4A. The headwaters of Trib 4A have experienced severe erosion with gully formation and

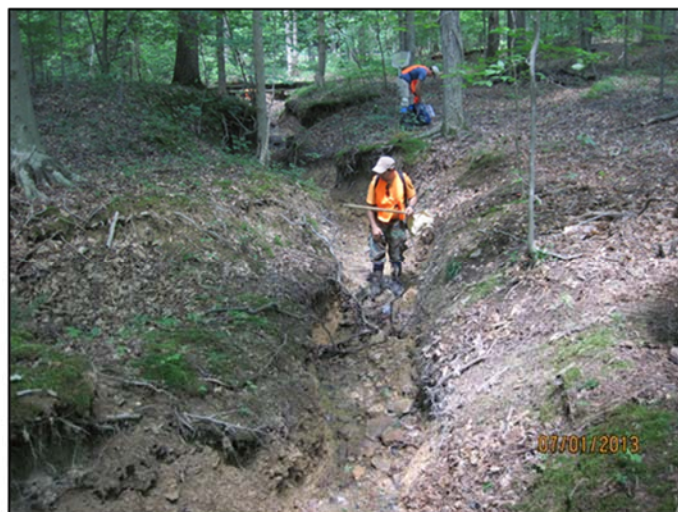
Photo 9.1. Trib 4 Upstream. 7.01.2013

stream entrenchment in the headwaters (Photo 9.1). Many trees were uprooted, blocking the stream path causing channel braiding in some areas. The stream has good sinuosity with the substrate made of mostly finer materials, not typical of a forested headwater stream, 70% gravel and sand substrate. The flow regime was interstitial drying in some places and reappearing with isolated pools. It drains approximately 0.13 square miles (81 acres), of which 68 % is forested.

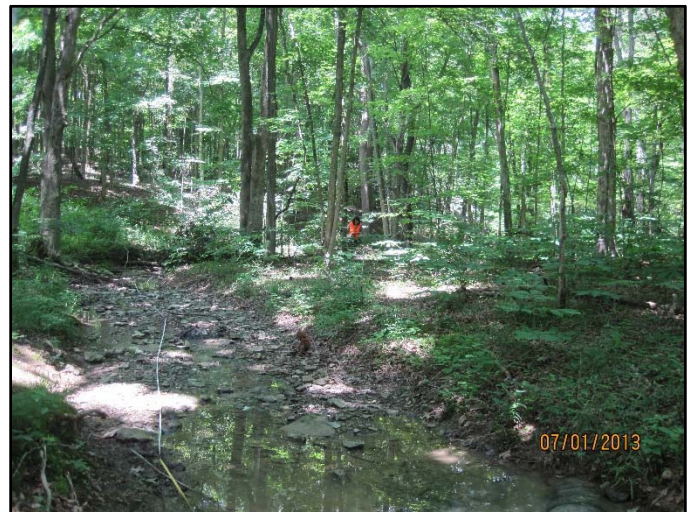
Photo 10. Trib 4B. 7.13.2013

Site description: Trib 4B located downstream of Trib 4A on the northwest side of DOE property. Trib 4B is the middle reach sandwiched between Trib 4A in its headwaters and Trib 4C downstream. The stream reach meanders through a mature bottomland and oak-hickory forest with a wide riparian corridor on both sides (Photo 10). The severe erosional features found in the headwaters of Trib 4A have less of an impact on physical stream characteristics at reach Trib 4B. The stream has some sinuosity with the substrate made of mostly cobble and gravel (70%).

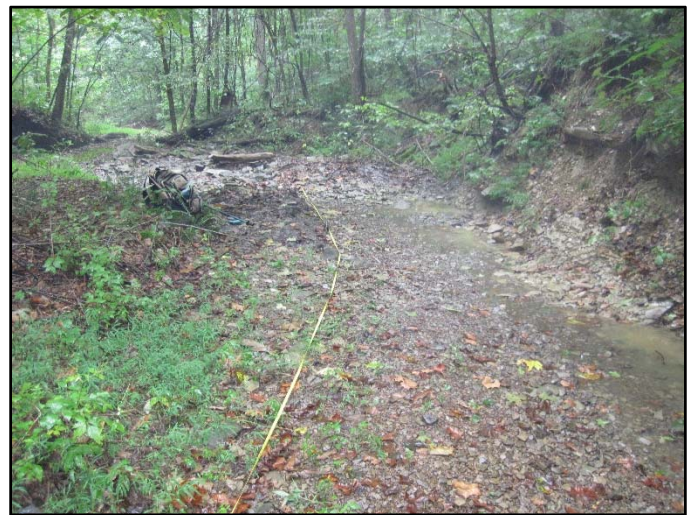
Photo 11. 4C. 8.27.2013

Site description: Trib 4C is located on the northwest side of PORTS adjacent to DOE property and connects on-site sections, Trib 4A and Trib 4B, to Little Beaver Creek. The stream reach was interstitial with isolated pools. The stream meanders through a mature bottomland hardwood and mixed mesophytic forest with a wide riparian corridor on both sides (Photo 11). The reach has moderate gradient (Figure 5.6), high sinuosity, and 75% boulder, boulder slabs, and cobble substrate. All three stream reaches in Tributary 4 together, drain approximately 0.31 square miles (196 acres), of which 72 % is forested.

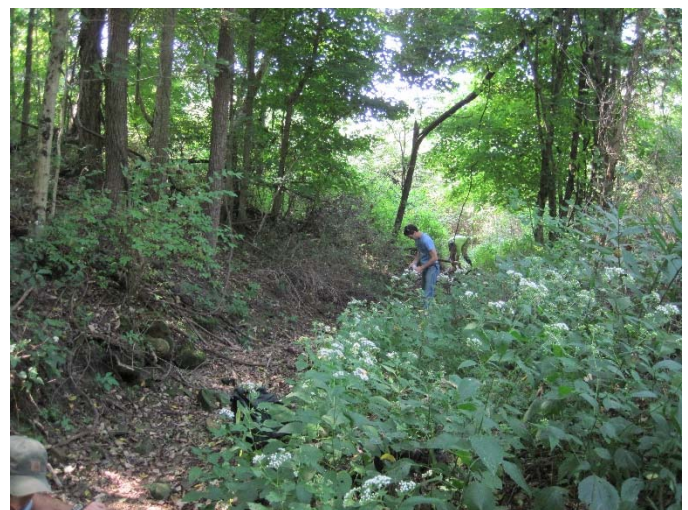
Photo 12. T1. 9.10.2013

Site Description: T1 located off DOE property on the northwest side of PORTS, drains into the Little Beaver Creek. The stream is an ephemeral dry channel (Photo 12) that flows through a late-Wisconsinan (15-18 ka) outwash terrace comprised mostly of sand and gravel. The substrate was comprised of approximately 75% gravel and sand, yielding an HHEI score of 40. Macroinvertebrates (HMFEI =0), salamanders, and fish were not found. It drains approximately 0.08 square miles (54 acres), of which 94 % is forested. Water quality parameters not collected, dry stream.

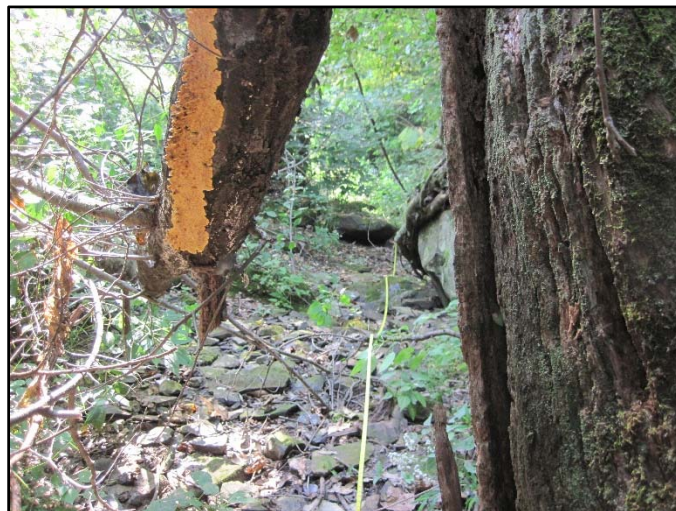
Photo 13. O1. 9.10.2013

Site Description: O1A located off DOE property on the west side of PORTS, flows into the Scioto River. The stream had a moist channel with one small isolated puddle. The stream flows from heavily forested uplands of mixed hardwoods into old field and palustrine habitat back into a successional forest on the right bank and shrub/scrub on the left bank with a wide to narrow riparian corridor, respectively (Photo 13). The reach has moderate gradient (Figure 5.7), minimal sinuosity, and 80% boulder, boulder slabs, and cobble substrate, yielding an HHEI score of 61 (Class II). It drains approximately 0.15 square miles (96 acres), of which 54 % is forested. Water quality parameters not collected, dry stream except for a small puddle.

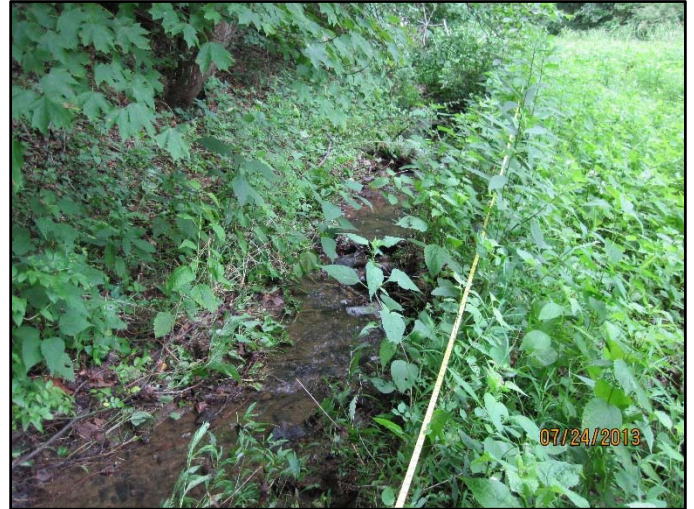
Photo 15. Trib 7. 7.24.2013

Site description: Trib 7 is located on the west side of DOE property, part of a tributary to the Scioto River. The stream reach is modified and flows along the old west entrance road. There is a wide mixed hardwood forested riparian corridor on the left side and no corridor along the old entrance road covered with ruderal overgrowth on the right (Photo 15). The stream was flowing when sampled on 7-24-13, however there had been significant rainfall within 24 hours prior to sampling. The reach has a moderate gradient (Figure 5.8), no sinuosity, and 50% gravel and sand substrate. It drains approximately 0.07 square miles (44 acres), of which 49 % is forested.

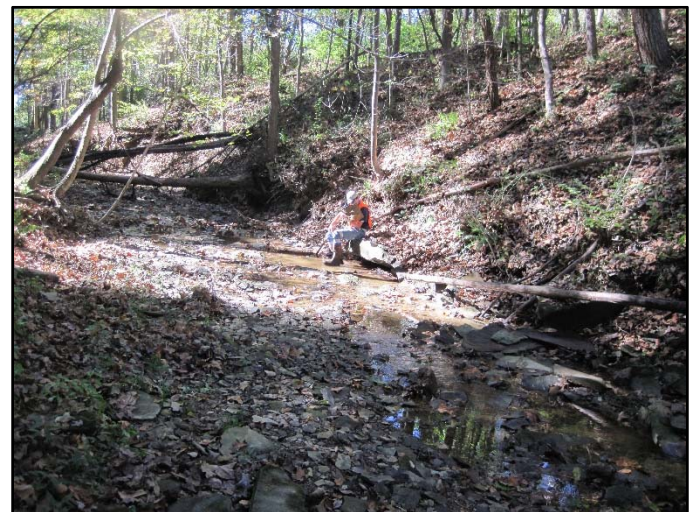
Photo 16. Trib 10. 10.10.2013

Site description: Trib 10 is located on the southwest side of PORTS located partially on DOE property, it flows into a tributary of the Scioto River. The stream reach flows from on-site through a control impoundment and descends into the alluvial plain and meanders through a diverse near-climax mixed hardwood forest with a wide riparian corridor on both sides (Photo 16). The reach is relatively flat, low gradient towards the mouth. However the headwaters cross a road through a culvert and flows through a treatment impoundment on DOE property (Figure 5.10). The reach has very little sinuosity, and is comprised of 75% boulder slabs, boulders, bedrock, and cobble substrate. The stream had a steady flow draining out of the upstream impoundment. The drainage basin drains the southwest corner of PORTS, approximately 0.50 square miles (320 acres), of which only 10% is forested.

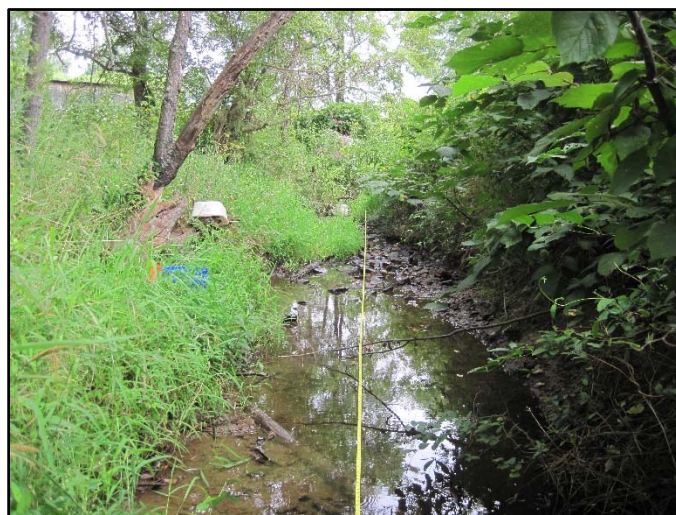
Photo 17. W1. 8.27.2013

Site description: Trib W1 is located on the south side of PORTS, partially on DOE property and is a tributary of Big Run. The stream reach flows from on-site and meanders through successional forest, and agricultural and maintained habitats with a narrow to moderate riparian corridor on right and left bank, respectively (photo 17). The reach is relatively flat, low gradient (Figure 5.11). The reach has high sinuosity and is comprised of 55% gravel and sand substrate. The stream was flowing and had good channel morphology. It drains approximately 0.99 square miles (634 acres), of which only 16% is forested.

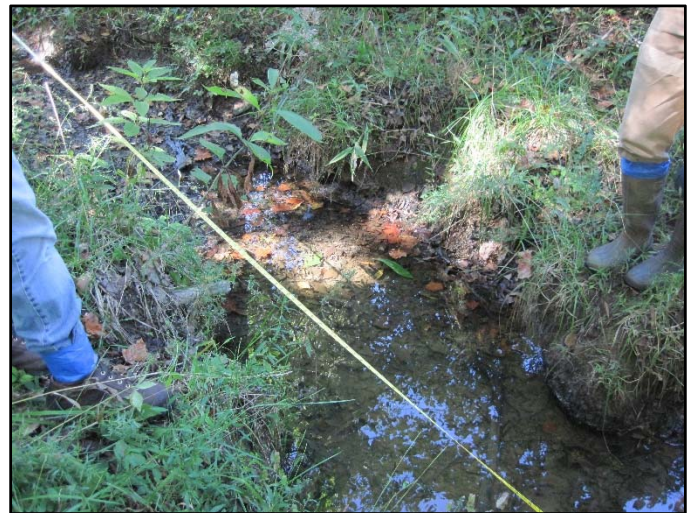
Photo 18. P1. 9.17.2013

Site description: Trib P1 is located on the southeast side of PORTS, off DOE property and is a tributary of Big Run. The stream reach flows through pasture and old field habitat (right) and mature oak-hickory forest (left) with a narrow to wide riparian corridor on right and left bank, respectively (photo 18). The reach has flat to moderate gradient (Figure 5.12). The reach lacked sinuosity with not much lateral movement and is comprised of 63% gravel and sand substrate. The stream flow was interstitial with bedrock outcropping with reach, found supplied most of water in channel. It drains approximately 0.17 square miles (109 acres), of which 27 % is forested. Note: conductivity was extremely high at this site, measured at the bedrock outcrop, primarily groundwater.

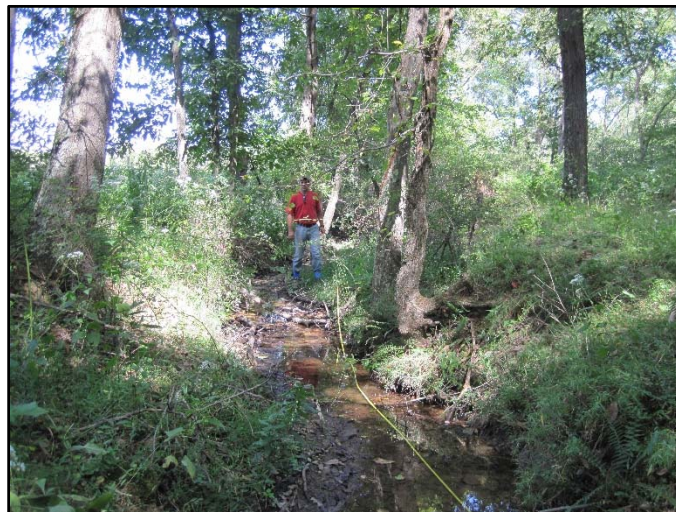
Photo 19. N1. 9.17.2013

Site description: Trib N1 is located on the east side of PORTS, off DOE property and is a tributary of the headwaters of Little Beaver Creek. The stream reach flows through pasture and successional old field habitat (left) and mature mixed hardwood forest (right) with a narrow to wide riparian corridor on left and right bank, respectively (Photo 19). The reach has flat to moderate gradient (Figure 5.13). The reach has very little sinuosity and is comprised of 60% gravel and sand substrate. The stream flow was intermittent, with one large pool located downstream of a 'head-cut', an erosional feature. It drains approximately 0.10 square miles (67 acres), of which 45 % is forested.

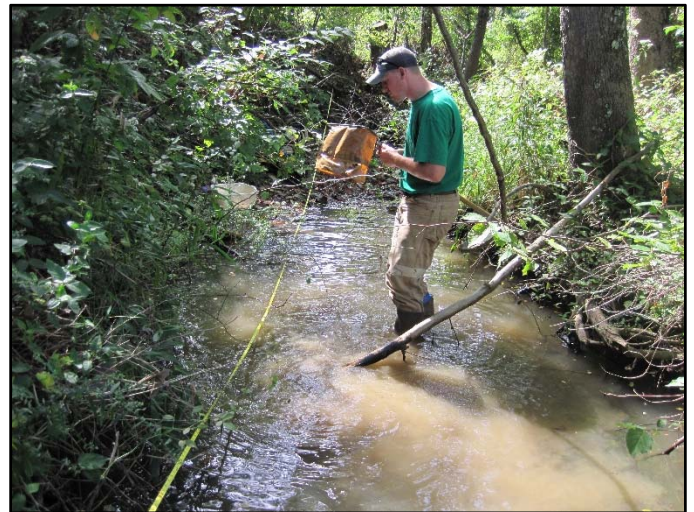
Photo 20. B1. 9.17.2013

Site description: Site B1 is located on the east side of PORTS, off DOE property and is a tributary of the headwaters of Little Beaver Creek. The stream reach flows from mature mixed hardwood uplands down through mostly agricultural lands with successional bottomland hardwoods and mixed shrub/scrub habitat along the stream corridor. The reach is relatively low gradient (Figure 5.14), slightly entrenched, and has minimal riparian corridor on either side (Photo 20). The reach lacks sinuosity and is comprised of 65% cobble and gravel substrate. The stream flow was intermittent, with pools throughout reach. It drains approximately 0.52 square miles (333 acres), of which 58 % is forested.

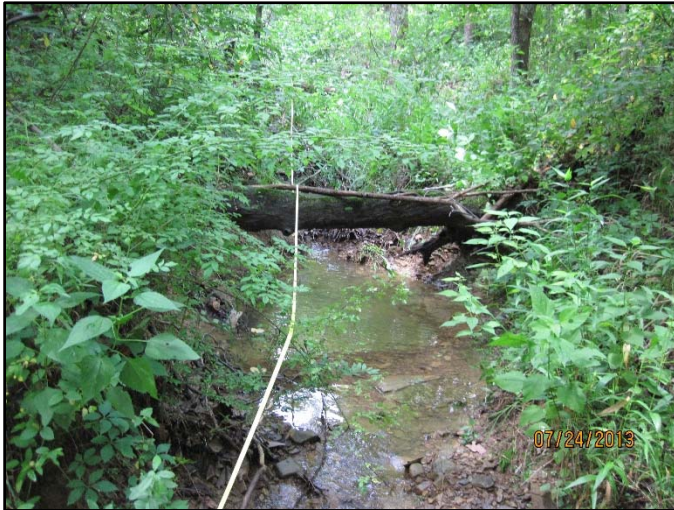
Photo 21. Trib 6. 7.24.2013

Site description: Trib 6 is located on the east side of DOE property and is a tributary of the headwaters of Little Beaver Creek. The stream reach flows from mature mixed hardwood forest uplands descending through a variety of successional habitats along its moderately wide stream corridor (Photo 21). Some exceptional forest habitat was found adjacent to this stream that hosts a number of plant species not previously reported from Pike County. The reach has flat to moderate gradient (Figure 5.15). The reach has high sinuosity and is comprised of 65% gravel and sand substrate. The stream was flowing when measured on 7-24-13. It drains approximately 0.09 square miles (55 acres), of which 63 % is forested.

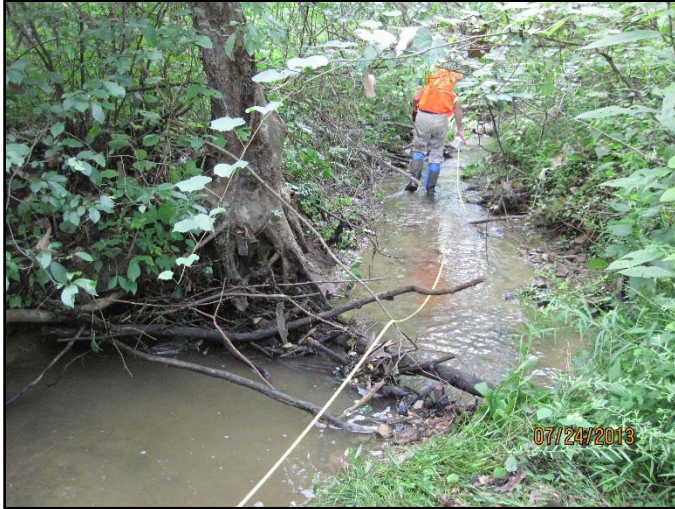
Photo 22. Trib 8. 7.24.2013

Site description: Trib 8 is located on the east side of PORTS, partially on DOE property. It is a tributary of Little Beaver Creek. The stream reach flows from mature mixed hardwood uplands then meanders slowly through a mixed bottomland hardwood forest with a wide riparian stream corridor (Photo 22). The reach has flat to moderate gradient (Figure 5.16). The reach has high sinuosity and is comprised of 52% cobble and gravel substrate. The stream was flowing when measured on 7-24-13. It drains approximately 0.19 square miles (119 acres), of which 48 % is forested (Forest cover determined from 2013 data, since then portions of the headwaters of this reach have been clear cut).

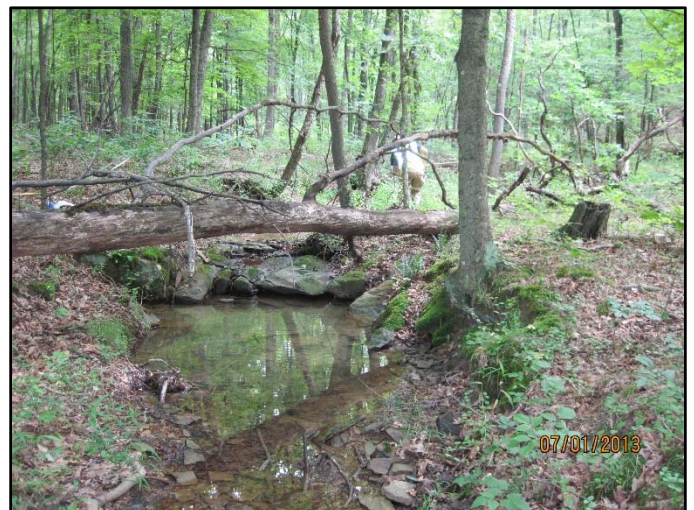
Photo 23. Trib 3. 7.01.2013

Site description: Trib 3 is located on the east side of DOE property. It is a tributary of Little Beaver Creek. The stream reach meanders through mature mixed hardwood forest and has wide riparian stream corridor (Photo 23). The mouth of this tributary contains extensive forested wetlands, these wetlands were not included in the reach surveyed. The sampled reach has moderate gradient (Figure 5.17) with good sinuosity and is comprised of 80% cobble and gravel substrate. The stream flow was interstitial with isolated pools. It drains approximately 0.11 square miles (69 acres), of which 98 % is forested.

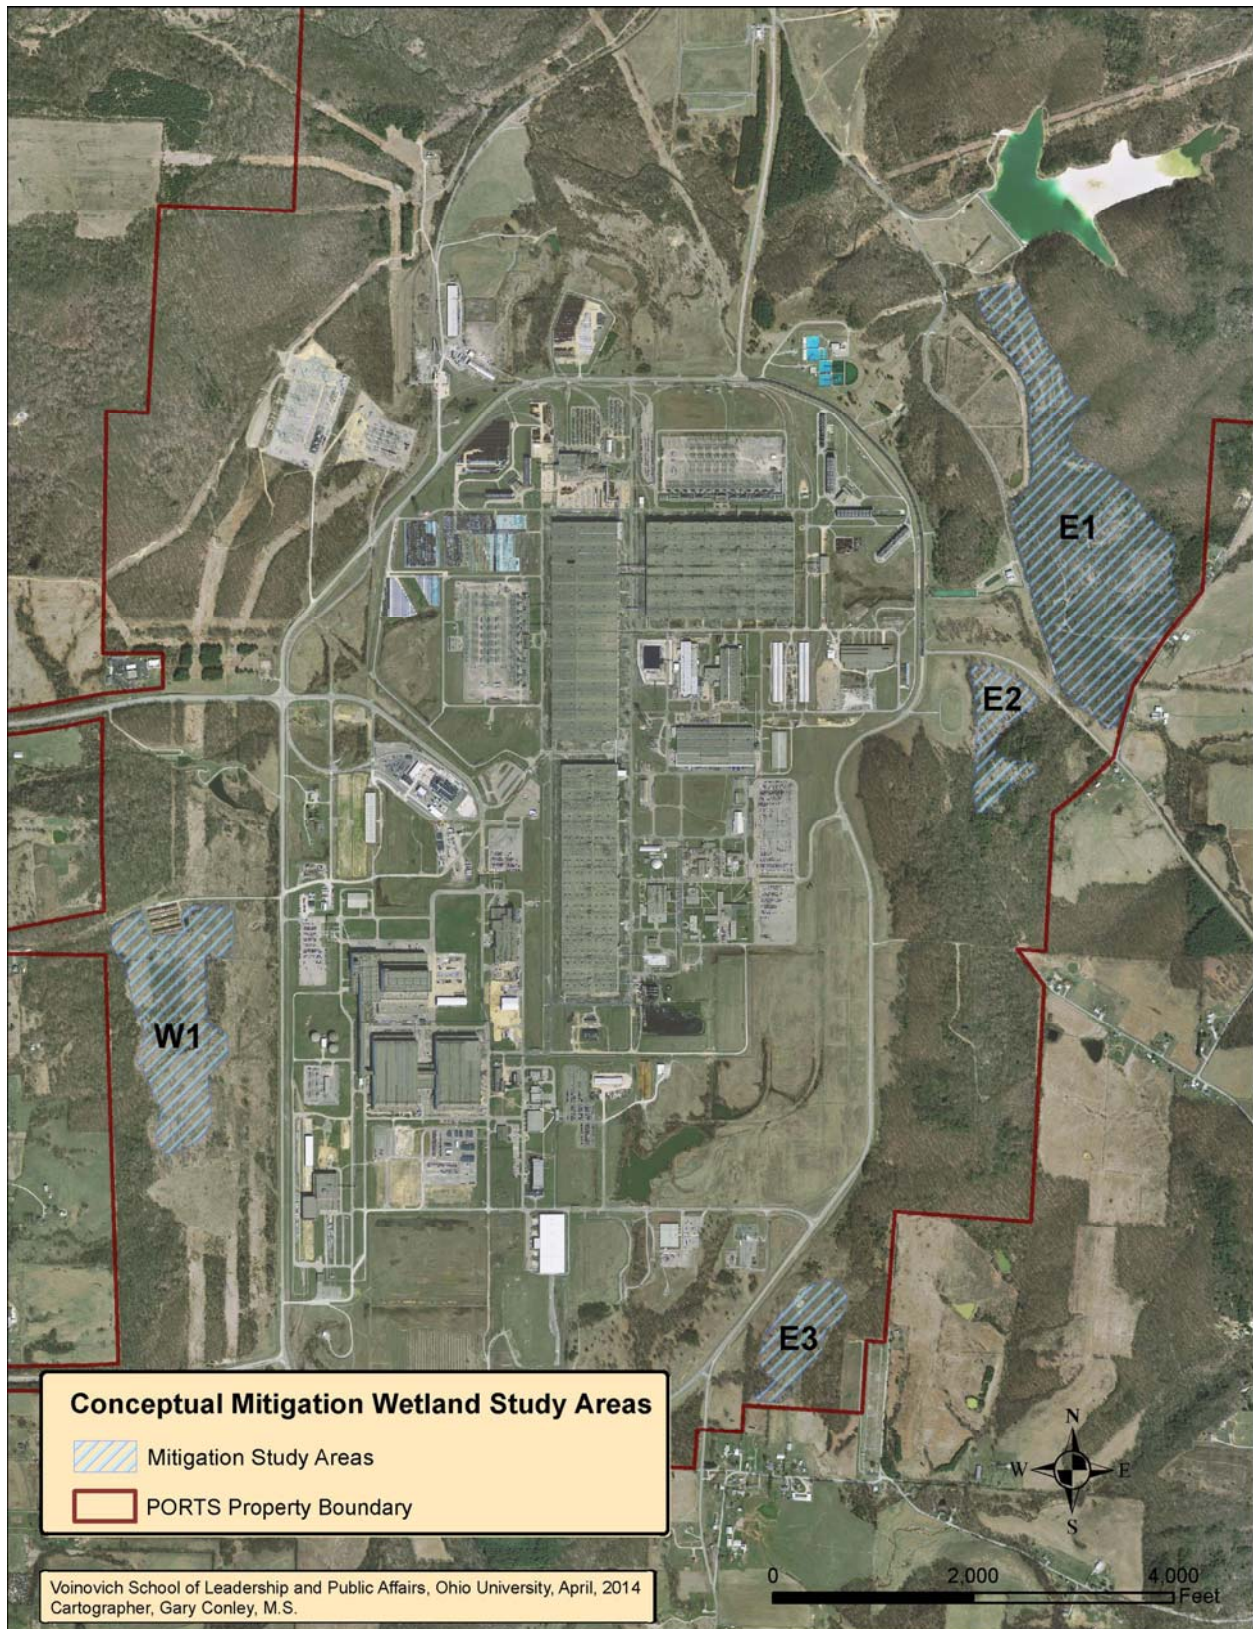
Figure 3.1 Conceptual mitigation study areas

Tentative mitigation sites were identified in the late summer of 2013. Figure 3.1 shows three locations within the PORTS reservation that emerged from the initial selection process. Wetland bank sites are described as clusters and identified for discussion as the “western cluster”, the “eastern cluster” and the “southern cluster”. Each cluster is composed of several discrete wetland units. A wetland unit is a confined pool (*wet pool*) with a distinct drainage basin¹ from which it receives runoff and at least one outlet control structure. The outlet control structure is generally considered to be a low earthen dam that may be fitted with a primary and emergency outflow structure.

These potential wetland mitigation sites are within mapped land use types identified as “Old field successional”, “ruderal successional”, “successional scrub” and “ruderal scrub-sapling”. All of these classifications describe vegetation communities that are either recovering from relatively recent vegetation and soil disturbance (i.e.; reestablishment by natural seeds dispersal mechanisms or root sprouting), or with ruderal types that experience disturbance (mowing, herbicides) on an annual or more frequent basis. Tentative sites were field inspected and characterized in May and July 2013.

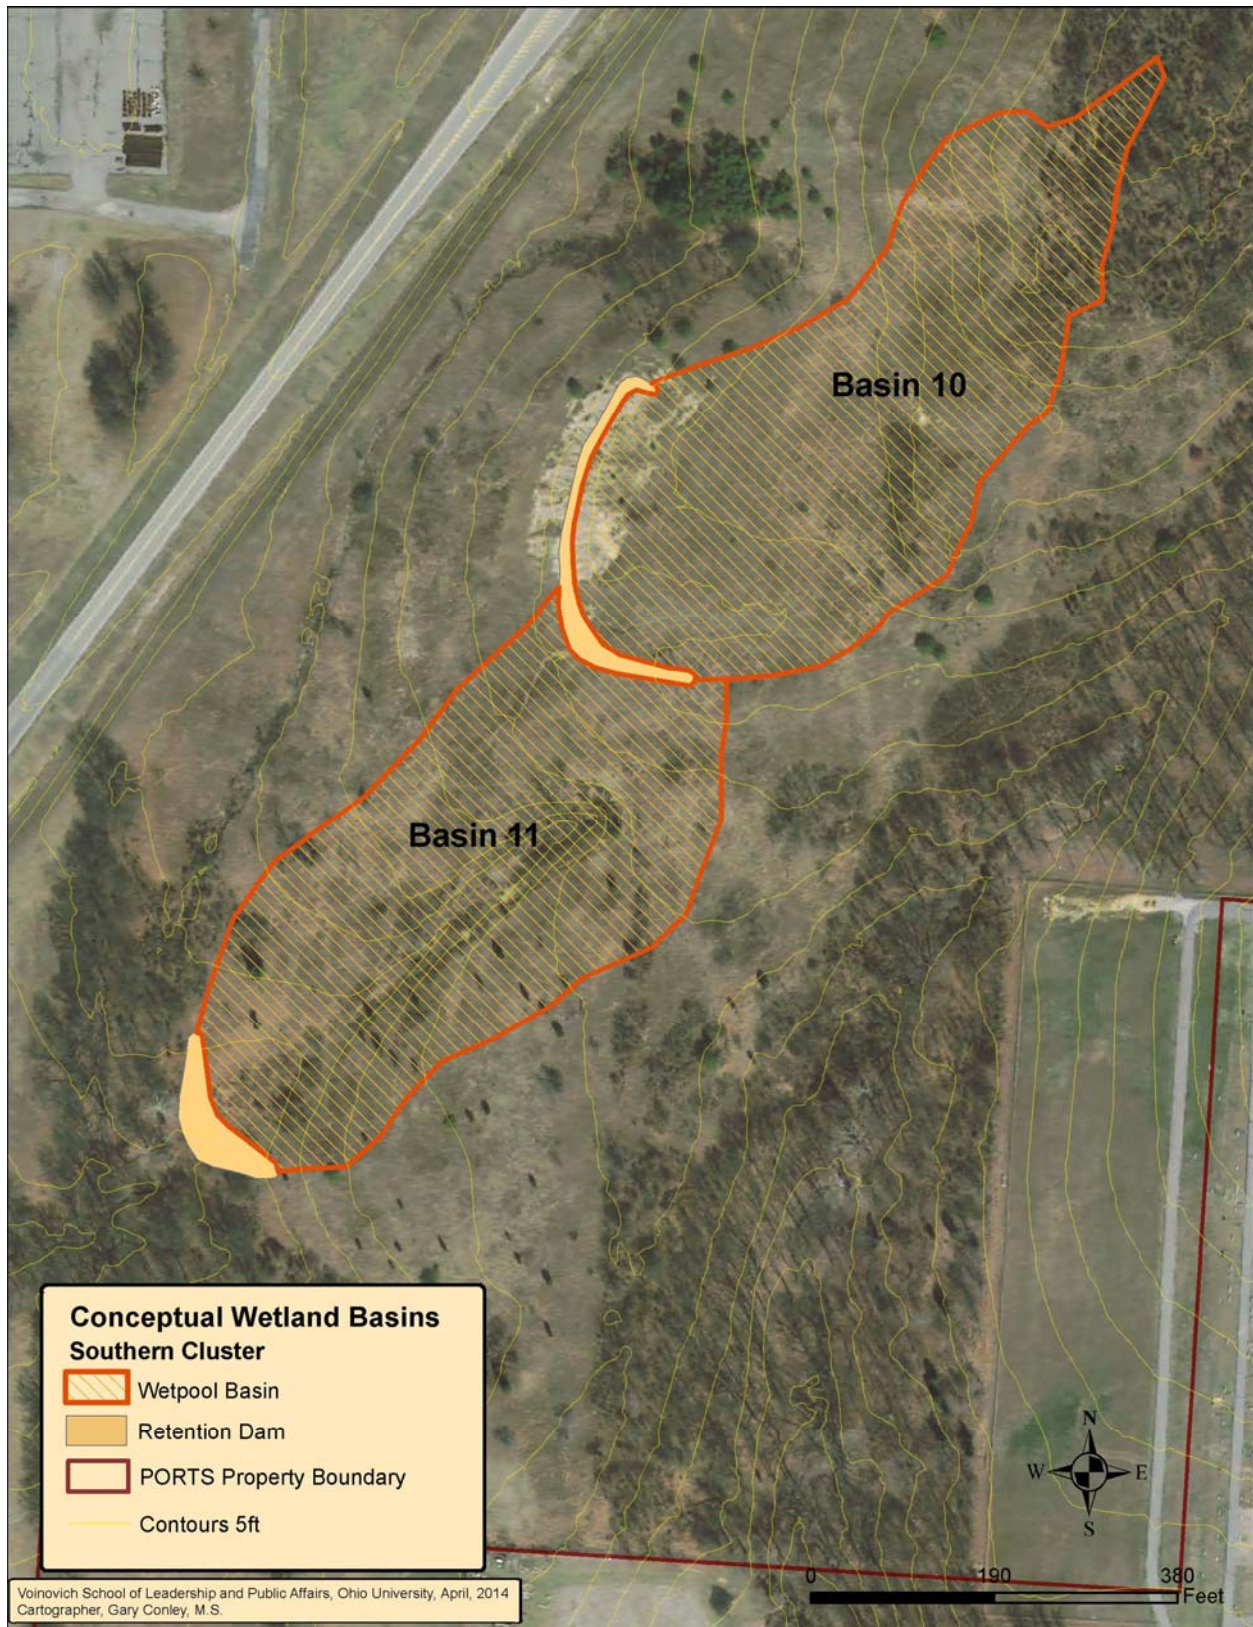
Figure 3.5 Southern cluster of conceptual wetland basins

The southern cluster of potential mitigation wetlands is shown on Figure 3.5. This area was selected for investigation because there is little evidence that the area had been used for other operational purposes, it is free of native forest vegetation and there is surficial evidence of springs that could enhance the hydrologic inputs to created wetlands. A small borrow area exists on the north side of the site that offers potential as a source for earth materials for dam building.
